C W SEARS/ TOFIELD SCHOOL VALUE SCOPING SESSION

Tofield, Alberta

January 2025

C.W. Sears Elementary School
Structural Investigation
5716 47 Street Tofield AB

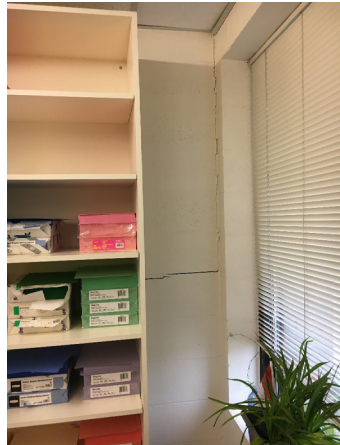
Where the interior non-loadbearing masonry partition walls connect to exterior or interior loadbearing masonry walls, which typically occur as a T-intersection, there are signs of vertical movement between these walls. The indications of relative movement included vertical, horizontal, and zig-zag cracking at the mortar joints between the masonry units of the interior partition walls (Photos 1 and 2).

Photo 1: Vertical and horizontal cracking of interior wall at intersection with exterior wall (Room 117)

The interior partition walls appear to be moving upwards relative to the loadbearing walls. This is most pronounced at the T-intersections between the interior and exterior loadbearing walls.

The masonry cracking observed in the base building's non-loadbearing interior walls appears to be the result of soil swelling (heave) below the slabs, which is causing the slab-supported walls to move upwards relative to the loadbearing walls, which are supported by grade beams on piles.

One way to mitigate the masonry cracking caused by this type of on-going soil movement would be to isolate the slab-supported walls from the pile-supported walls, allowing them to move relative to each other. This could be partially achieved by providing a vertical joint between the interior non-loadbearing walls and any exterior (or interior) loadbearing walls. However, this may not address cracking along the length of the wall, where there is differential subgrade movement from one end of the wall to the other, so some masonry cracking or door frame distortion might still occur.

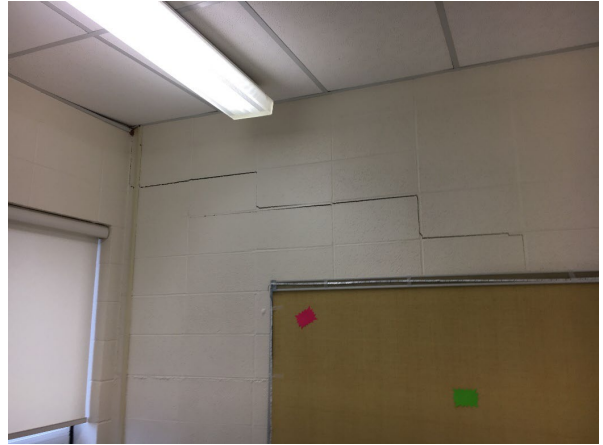
Photo 2: Zigzag cracking in wall between classrooms 111 and 112

In most locations, the observed slab heave and masonry wall cracking is not uncharacteristic for a building of this age and type of construction. However, in a few locations (such as Rooms 111/112 and Rooms 124/125, among others), the relative movement between the slab-supported and pile-supported walls is quite pronounced with highly visible and unsightly cracking.

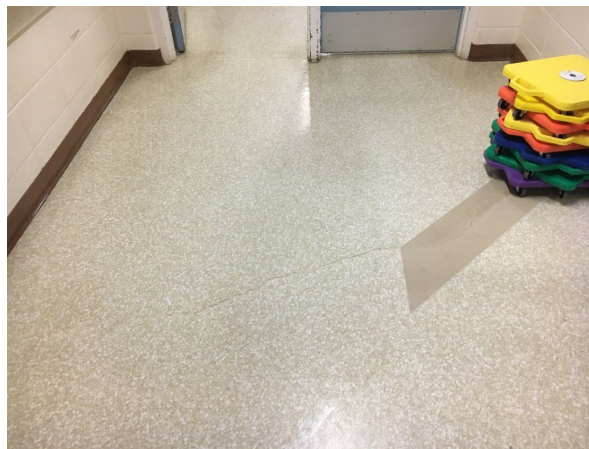
The main hallway slabs show signs of heaving with some slab cracking telegraphing through the vinyl floor covering (Photo 3). At other locations (e.g., Room 119) slab heaving is causing door frames to distort (Photo 4).

Photo 3: Slab cracking telegraphing through hallway vinyl floor covering

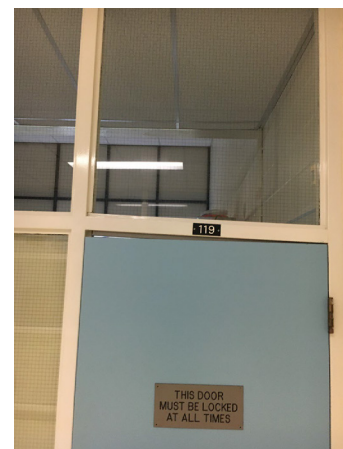
Photo 4: Door frame distorted due to slab heaving

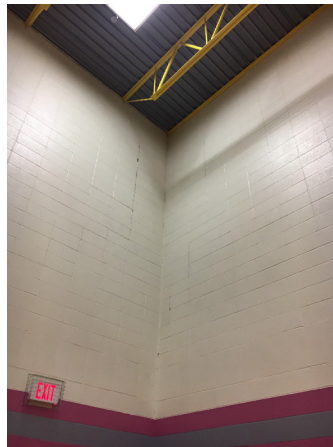
There is some vertical cracking in the gymnasium walls, typically at the four corners, two or three block widths in from the corners (Photo 5). These vertical cracks are more pronounced at the top of the wall but do not appear to extend below the horizontal bond beam located at approximately the height of the lower roof.

Photo 5: Vertical masonry cracking at corners of gym walls

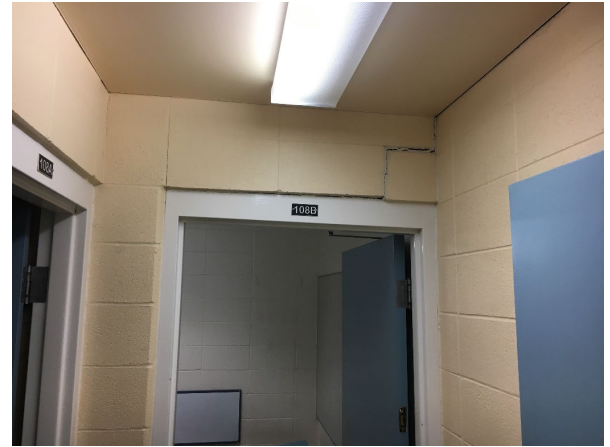
In the change rooms adjacent to the gym, there is some masonry cracking above the door frames (Photo 6).

Photo 6: Masonry cracking of header above Room 108B door frame

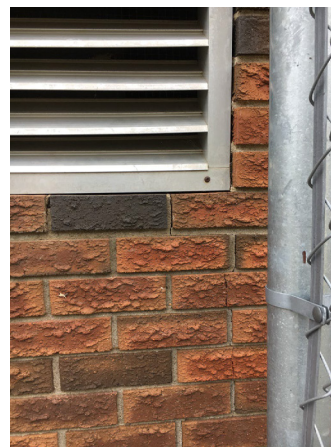
RJC's review of the exterior of the base school building did not reveal any significant cracking in the brick veneer that would indicate issues with the underlying masonry walls. Some minor brick cracking was noted at the corners of the mechanical room louvers (Photo 7).

Photo 7: Cracking of brick veneer at mechanical room louver opening

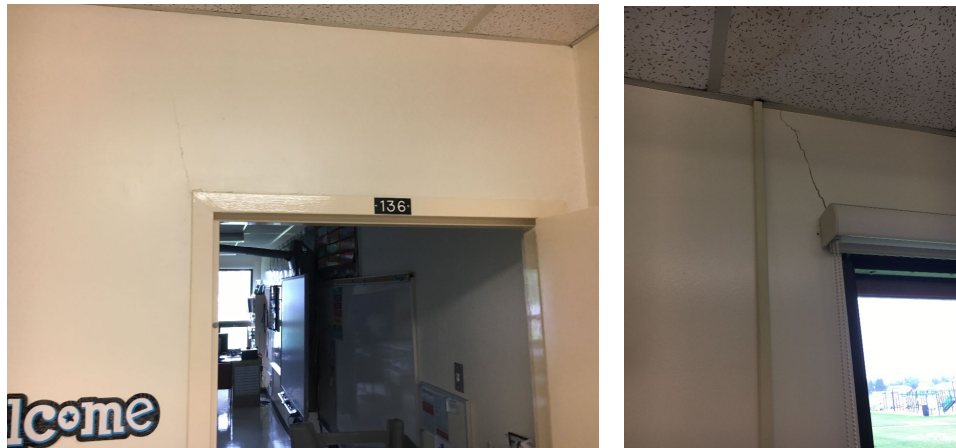
No significant structural issues were observed inside the modular classrooms. There is some minor, predominantly vertical, slightly diagonal cracking over door and window openings, at the corners of these openings (Photos 8 and 9).

Photos 8 and 9: Minor drywall finish cracking over door and window

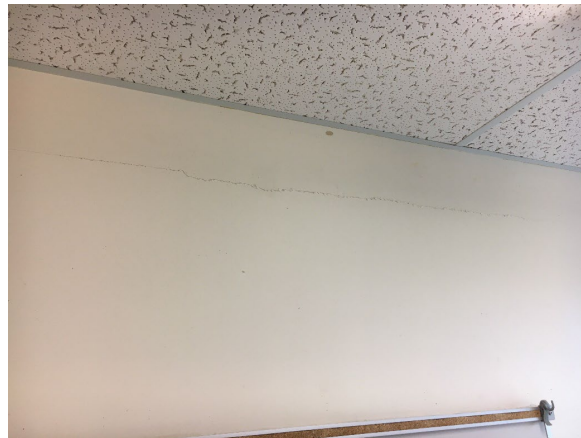
In Room 138, there is an extended horizontal crack above the white board on the south wall (Photo 10).

Photo 10: Horizontal finish crack above whiteboard in Room 138

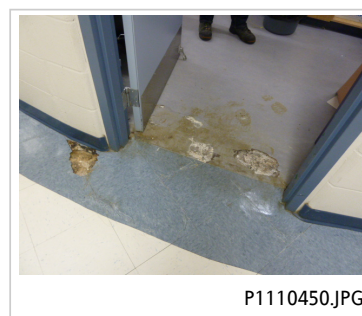
P1110450.JPG

(1959) Addition (Corridor) - has spalling concrete slab.

Impact: Moderate	Category: Lifecycle	
Priority	Year	Estimated Cost
0 - Due at time of Inspection	2013	\$12,664
Project Number	Project Status	Last Updated in VFA
		Apr 27, 2016

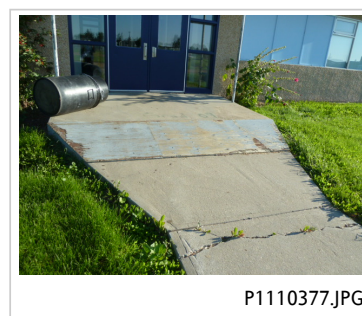
P1110377.JPG

(1952) Original Building (Southeast Corridor Exit) - has rotten plywood ramp.

Impact: Minor	Category: Lifecycle	
Priority	Year	Estimated Cost
0 - Due at time of Inspection	2013	\$1,900
Project Number	Project Status	Last Updated in VFA
		Apr 27, 2016

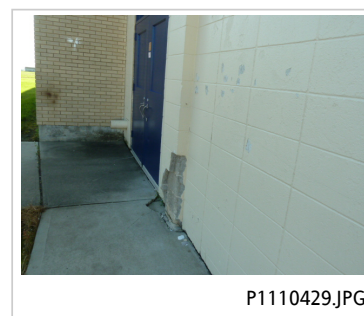
(1971) Addition - has damaged concrete block pilasters due to heaving sidewalk.

Impact: Moderate	Category: Reliability	
Priority	Year	Estimated Cost
0 - Due at time of Inspection	2013	\$5,699
Line Item	Quantity	Unit Cost Units
Repair 9 concrete block pilasters.	9	\$633.25 each
Project Number	Project Status	Last Updated in VFA
		Apr 27, 2016

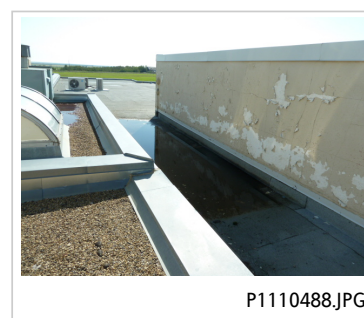
P1110488.JPG

(1958) Addition (north wall above low roof) - paint on concrete block wall has peeled off. (approx. 50 square metres)

Impact: Minor	Category: Reliability	
Priority	Year	Estimated Cost
0 - Due at time of Inspection	2013	\$3,166
Line Item	Quantity	Unit Cost Units
Repaint exterior wall - 1958 Section. (approx. 50 square metres)	50	\$63.32 sm
Project Number	Project Status	Last Updated in VFA
		Apr 27, 2016

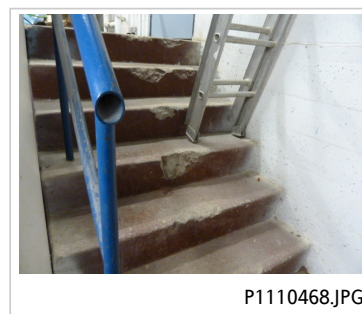
P1110468.JPG

(1958) Addition (Mechanical Room 201) - concrete stair has damaged nosing.

Impact: Minor	Category: Reliability	
Priority	Year	Estimated Cost
0 - Due at time of Inspection	2013	\$1,266
