C W SEARS/ TOFIELD SCHOOL VALUE SCOPING SESSION

Tofield, Alberta

January 2025

C.W. Sears Elementary School
Structural Investigation
5716 47 Street Tofield AB

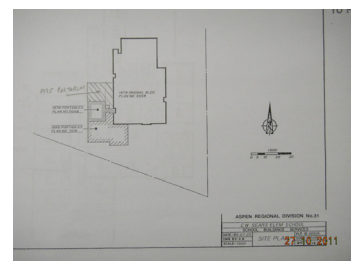
DSCN6205.JPG

Note: Snow covering at the time of audit limited thorough inspection

Condition Rating	Installed	Lifetime	Years Remaining
C - Acceptable	2017	150	N/A
Date Inspected	Quantity	Unit Cost	Units
	1	\$0.00	Each
		Renewal Cost	Last Updated in VFA
		\$0	Mar 29, 2018

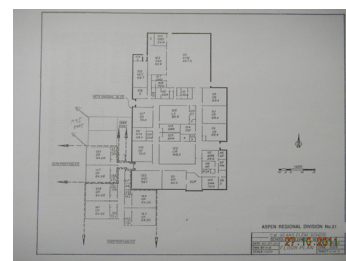
DSCN6206.JPG

Note: Snow covering at the time of audit limited thorough inspection

Condition Rating	Installed	Lifetime	Years Remaining
C - Acceptable	2017	150	N/A
Date Inspected	Quantity	Unit Cost	Units
	1	\$0.00	Each
		Renewal Cost	Last Updated in VFA
		\$0	Mar 29, 2018

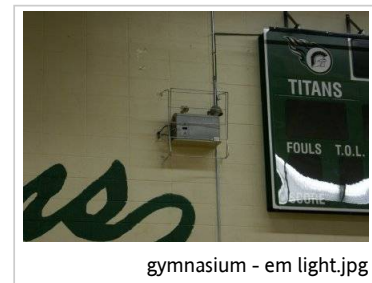
Auto generated renewal for 1971 Addition. System Description: N/A

Impact:	Category:	Lifecycle	Estimated Cost
Priority	Year		
Lifecycle Planning (at least 4 years remaining at inspection)	2030		\$11,642
Project Number	Project Status	Last Updated in VFA	
		Apr 27, 2016
